MAXE ROLLATOP

TROUBLESHOOTING MANUAL

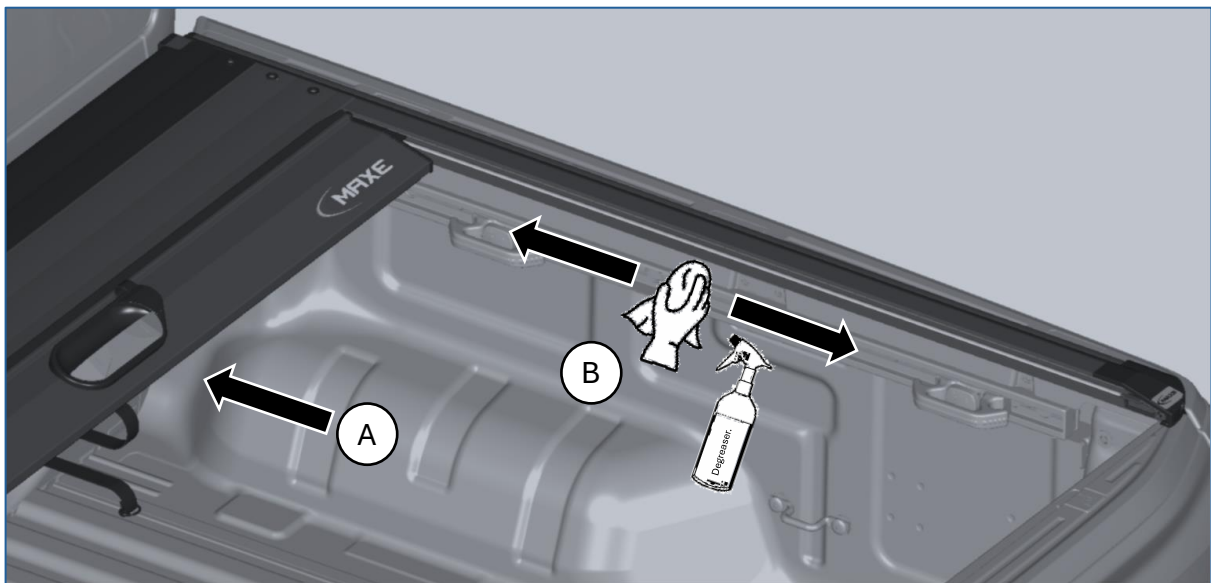
Figure.1 - Open RollaTop completely then clean the channels and white plastic strips with a brush or cloth.

If not regularly cleaned the side rails will become dry or dirty, this will prevent the Rollatop from operating correctly. To correct this problem, first clean the white plastic strips on either side rail with a rag / cloth. Ensure to remove all the dirt build up along the length of the plastic strips and any other items / dirt that may be in the channels such as leaves & stones. A cleaning agent may be used such as a degreaser. Once free from dirt a silicone-based grease is recommended to lightly lube the white plastic strips on either side. A Q20 / WD40 spray may be applied to a rag and used to wipe the white plastic strip though this method might not last as dust will stick to the plastic strips and build up in a short period of time causing the operation to not work correctly / smoothly.

Ensure that the side rails have been cleared of all dirt and a silicone based greased has been applied to both sides. (as per Section 1A – Figures 1 & 2) prior to further adjustment.

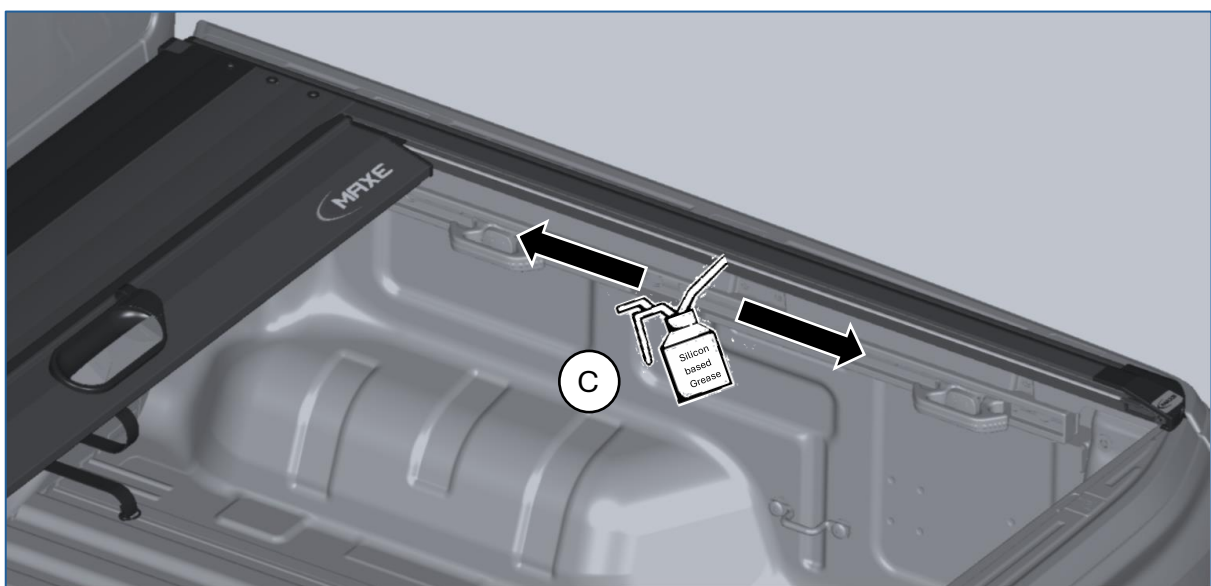
Figure.2 - Apply a silicon-based grease to the white plastic strips.

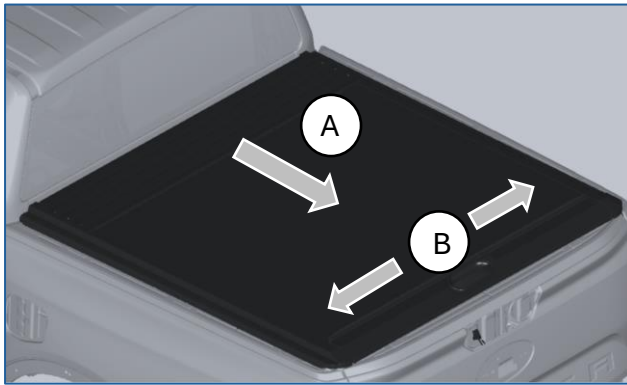
Figure.3 – Close the Rollatop and move the rear profile side to side. Free movement should be 3mm to 6mm.

If the side rails have not been installed correctly / parallel to each other, the Rollatop will not be able to move / close freely. To Check if this is an issue try closing the Rollatop then move the rear profile side to side. The rear profile should be able to move 3mm to 6mm from side to side.

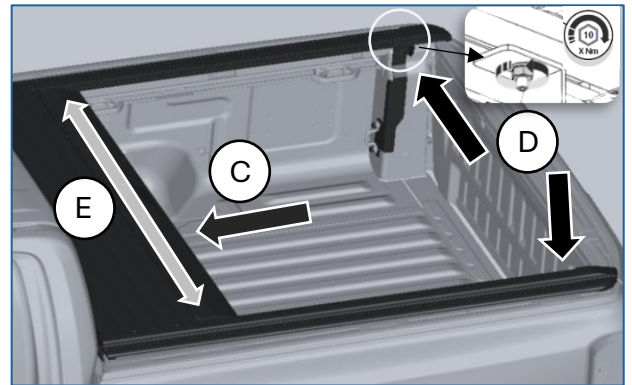
Figure.4 – Open the Rollatop and then slightly loosen the rear brackets from the RH and LH side rails at the tailgate end. Measure between the side rail just after the fixed lid profile.

If this is not the case and the movement is excessive or less than required then to correct the problem, open the Rollatop fully then slightly loosen the rear brackets from the side rails on either side of the tailgate. Next measure the distance between side rails as shown in Figures 4 and 5. Use this measurement to re-align the end of the side rails by then tailgate the tighten the brackets.

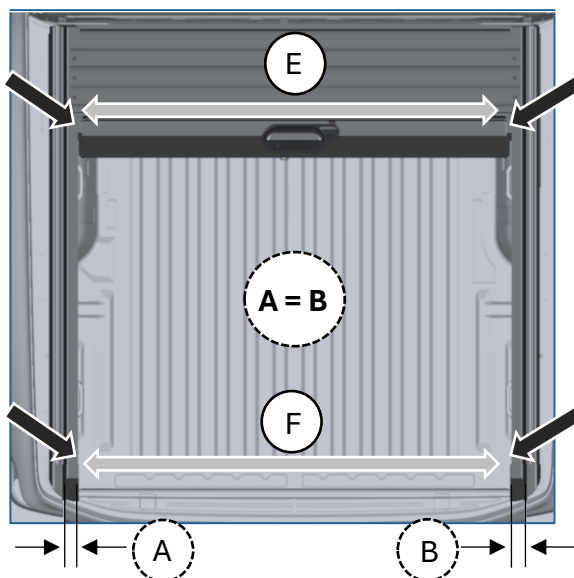
Figure.5 – Measure between the side rail just after the fixed lid profile.

Use this measurement to re-align the side rails at the back. Ensure RollaTop is centred (A=B). See Table 1 for standard measurements.

See Section 1B – Figures 4 & 5, then see Figures 12 to 15 below.

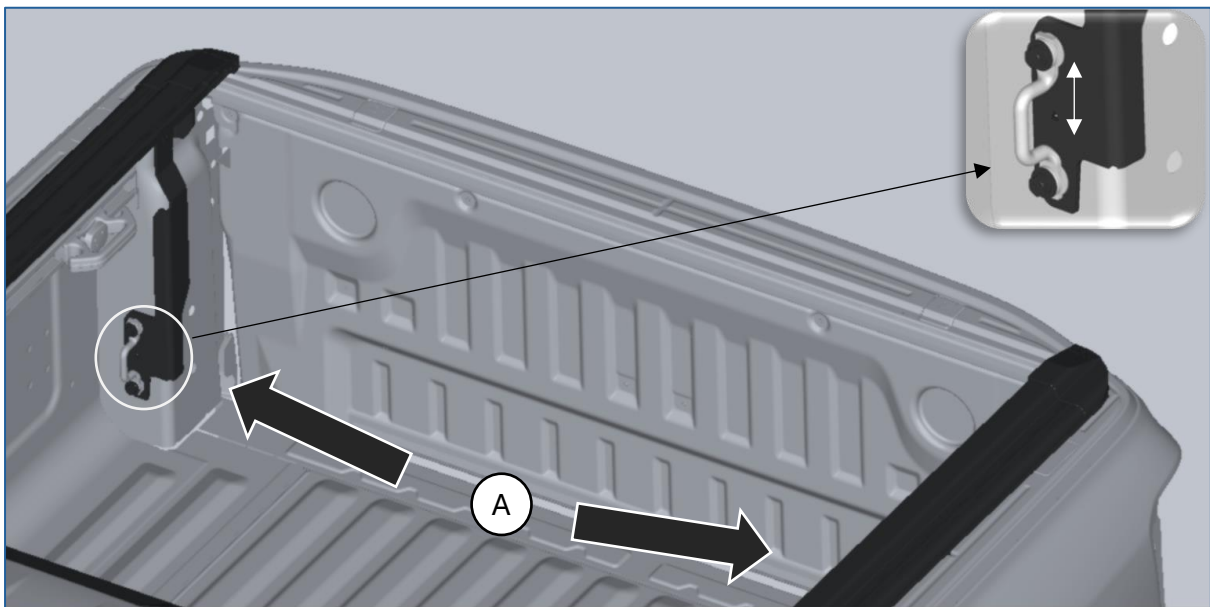
Figure.6 – Open the Rollatop and Tailgate. Slightly loosen the 2x M8 bolts on either side bracket.

To correct this, open the Rollatop and Tailgate, locate the two end brackets on either side of the tailgate. An adjustment needs to be made to these to either increase or decrease the gap between the Rollatop rear profile and the tailgate top surface.

See section 1C – Figures 6 & 7 for correct placement.

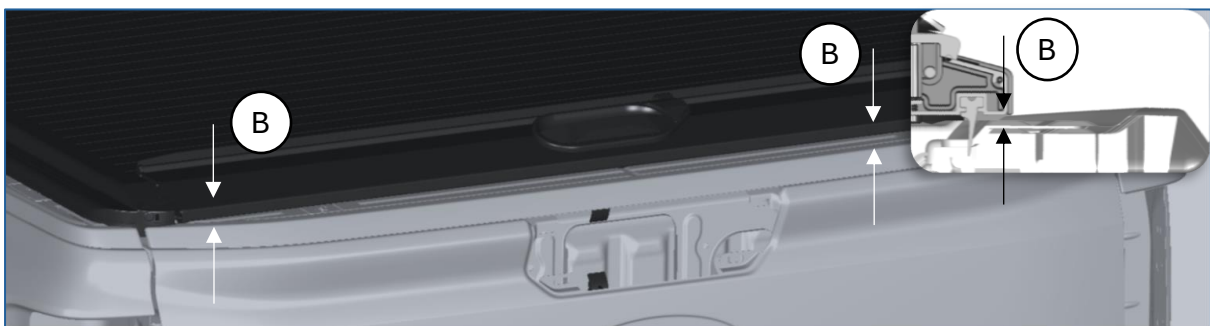
Figure.7 – Adjust the two rear brackets up or down until the gap between the rear profile and the top of the tailgate surface is 10mm.

Finally ensure that the vertical **gap** between the underside of the rear profile and the top surface of the tailgate in a closed position is 10mm as shown in Figure 7.

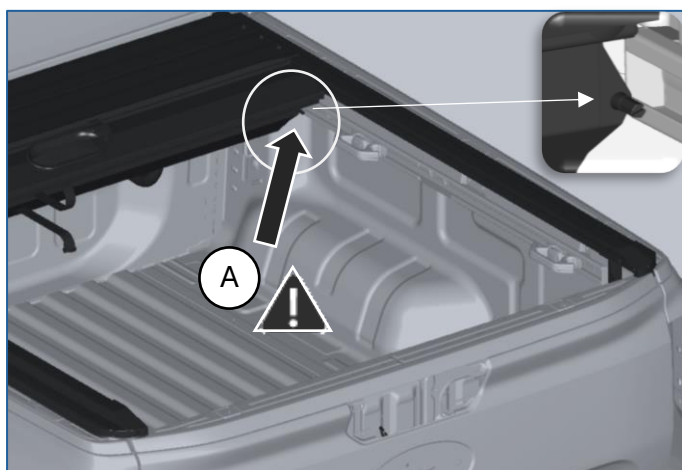
Figure.8 – Open the Rollatop and locate the index tensioning pin.

Or the tension setting on the spring is set to a manually assisted tension setting and will require a gentle push (as per Section 1D – Figures 8 & 9).

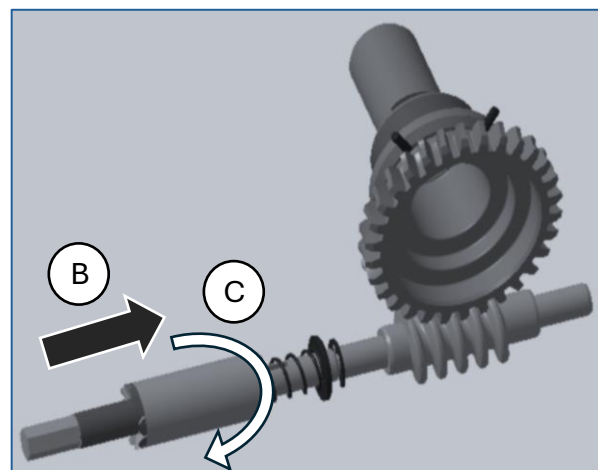
Figure.9 – Press the index tensioning pin inwards and rotate. Clockwise to increase and anti-clockwise to decrease the spring tension.

Adjusting the main spring in clockwise rotation will increase the tension and make manually closing the cover harder but opening the cover will be easier.

Then if the opposite is done, adjusting the spring in an anti-clockwise rotation the tension shall be reduced making the cover easier to manually close but opening will become semi-automatic / manually assisted too fully manual.

Adjust the tension in increments, a cordless drill with a 7mm socket may be used. Try rotating the index tensioning pin by ten (10) rotations and then try closing and opening the Rollatop. If the result isn't satisfactory then try adjusting the tension further.

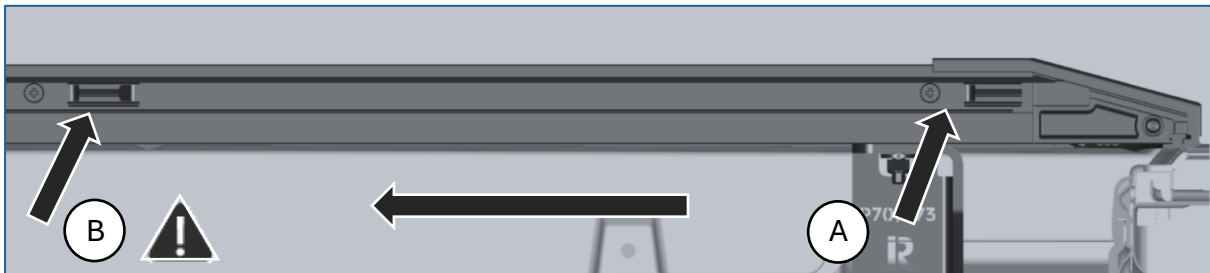
Figure.10 – When opening the Rollatop the lid will stop at a mid-stopping position which is 400mm from the fully closed position.

It is important to know that while opening, the lid will stop at 400mm from the fully closed position, this position is known as the mid-stopping position. Do not force the lid open from this position. As this may result in damages to the locking pins.

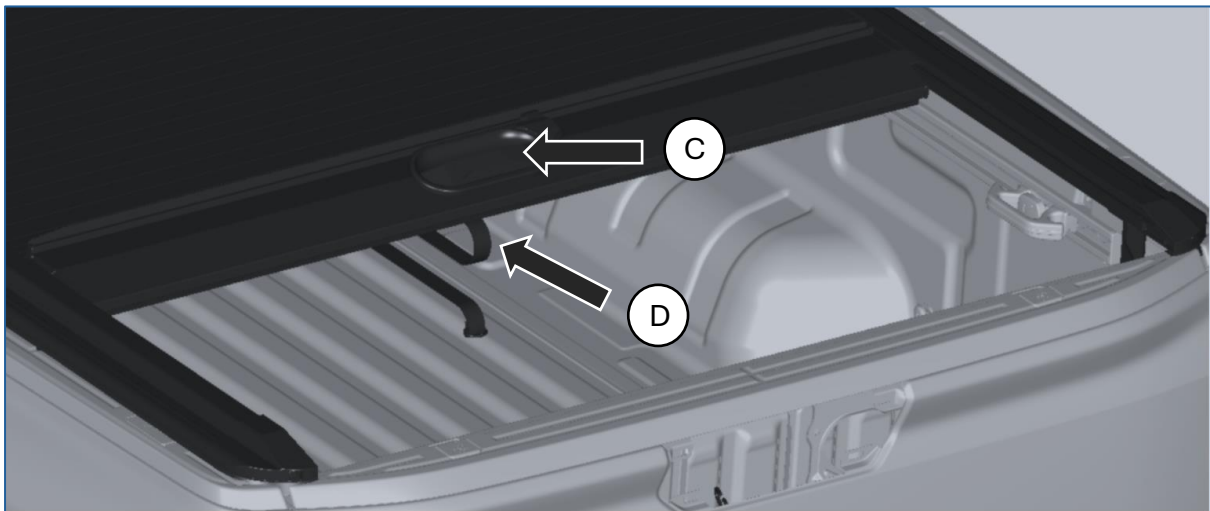
Figure.11 – Opening the lid from the mid-stopping position either use the handle and gently push the lid to unlatch or gently pull on the draw chord, this will unlatch the locking pins.

To continue opening please use the handle or draw cord to unlatch from the mid-stopping position and continue to the fully open position.

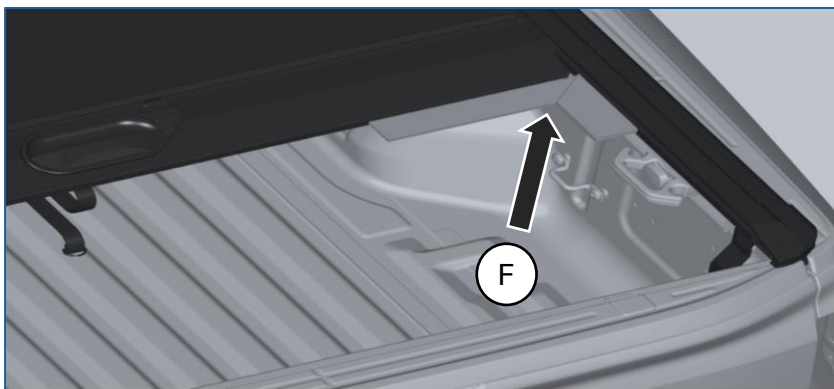
Figure.12 – Measure the angles between the side rails and the rear profile. These measurements should be 90 degrees.

To correct this problem, loosen the rear brackets, re-align the side rails by measuring the angles between the side rails and the rear profile. Ensure that these angles are 90 degrees and re-tighten the brackets correctly.

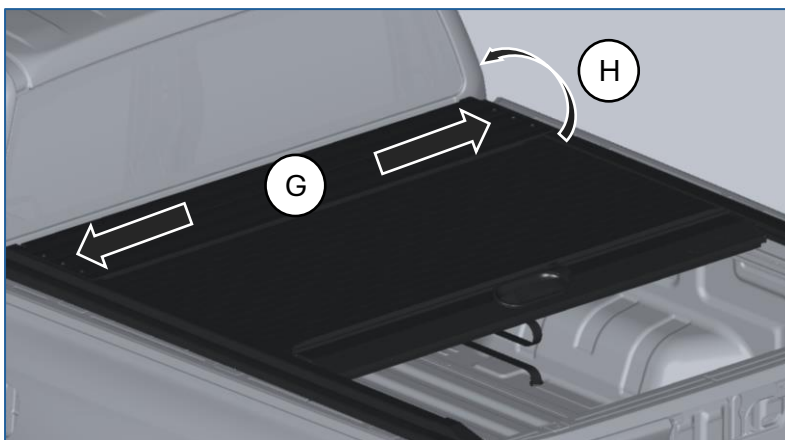
Figure.13 – If 90 degrees setting can't be achieved in previous step – Loosen 6x button head caps screws on the fixed lid and rotate the fixed lid to the open maintenance inspection position.

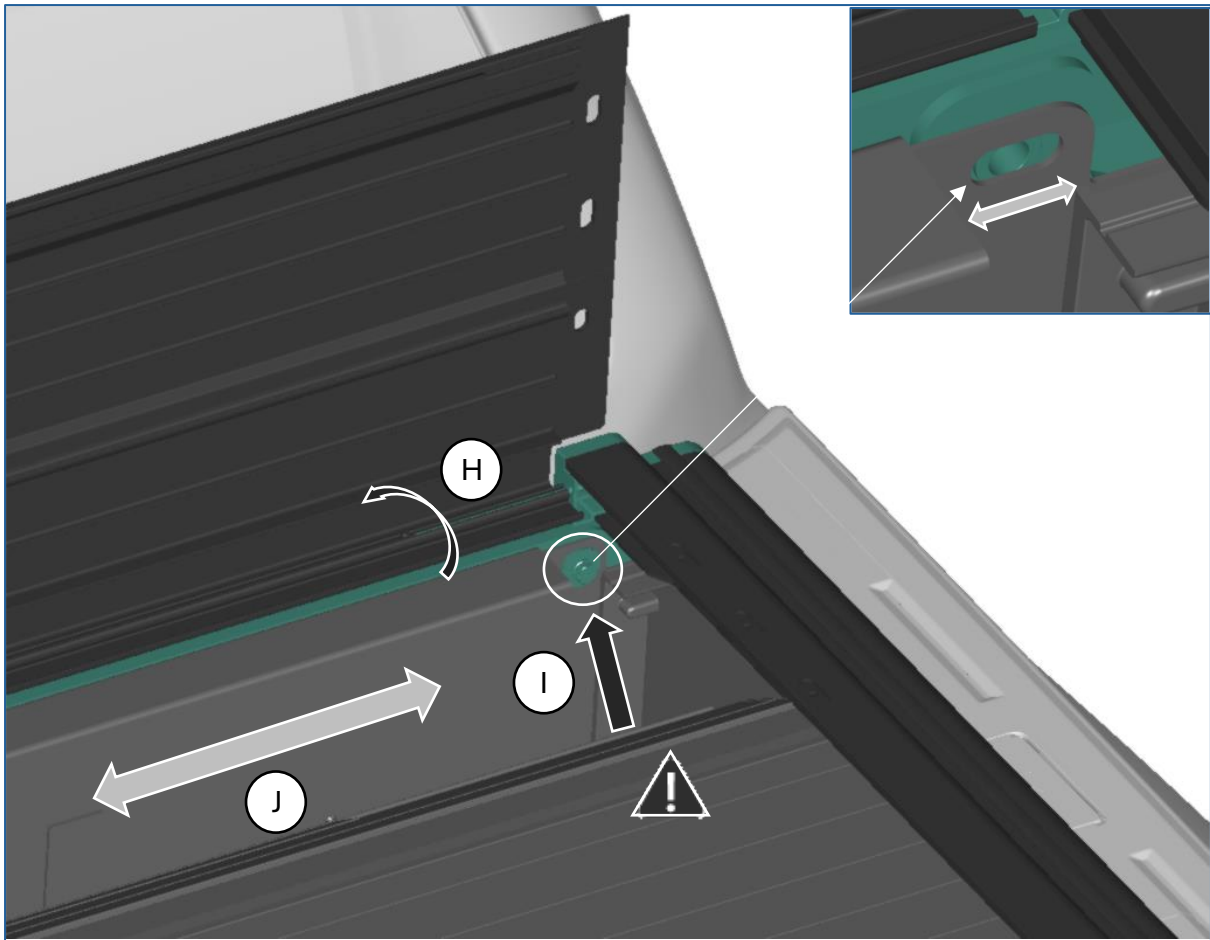
Figure.14 – Loosen 6x button head caps screws on the fixed lid and rotate the fixed lid to the open maintenance inspection position.

Next locate the 2 (two) M6 hex bolts on either end, slightly loosen these and shift the collection cylinder either to the left or to the right. By doing this the Rollatop will be shifted slightly on top of the load body / vehicle bin. Once set re-tighten the two hex bolts.

Please not there is about 5mm travel either way with the slotted hole.

Cleaning of the collection cylinder, as per section 2C – Figure 14. Loosen the 6x button head cap screws from the fixed lid.

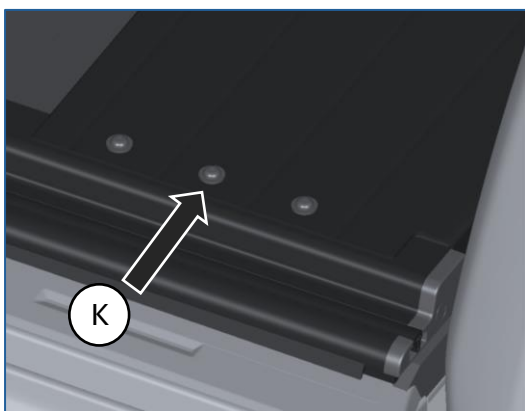
Figure.15 – Rotate the lid back into its closed position and tighten the 6x button head caps screws on the fixed lid.

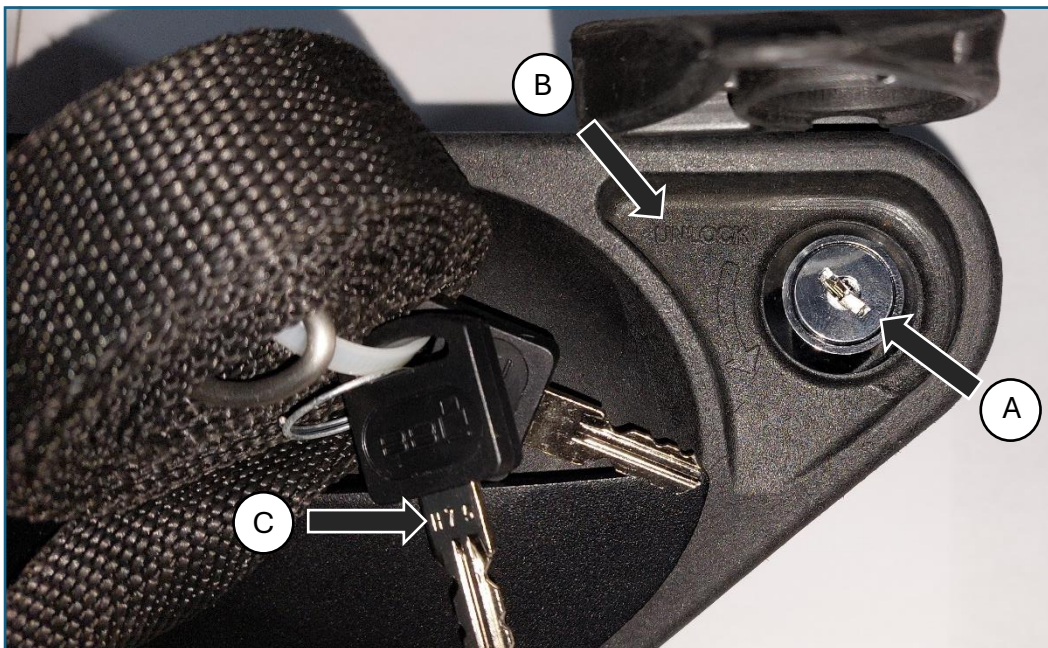
Figure.16 – Shown above is the lock cylinder, unlocking direction and the location of the BBL key serial number.

If the Rollatop is used in dusty areas the lock unit may become stuck. To correct this problem, apply a small amount of Q20 / WD40 spray into the key slot to loosen up the internals. Next insert the key and rotate the key 90 degrees back and forth to loosen up the lock cylinder.

It is important to know that the key when inserted must be rotated a full 90 degrees in a clockwise motion to lock the Rollatop and release the key. To unlock the Rollatop the key must be inserted and rotated a full 90 degrees in an anti-clockwise direction as shown in Section 3A – Figure 16.

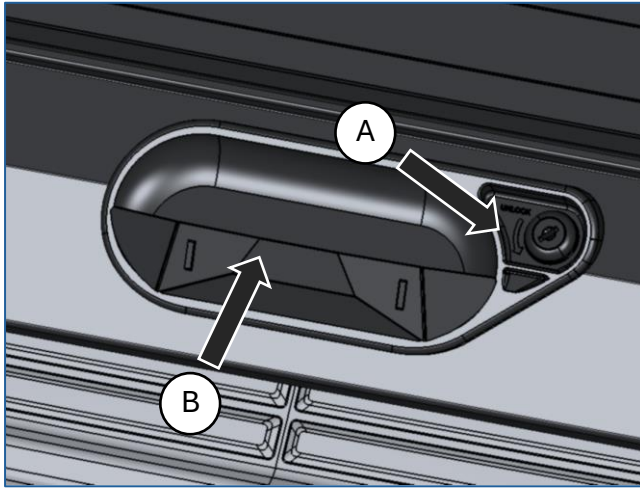
Figure.17 – Shown above is the lock mechanism and the direction to unblock the Rollatop. Once unlock the key has been released pull the handle to open the Rollatop.

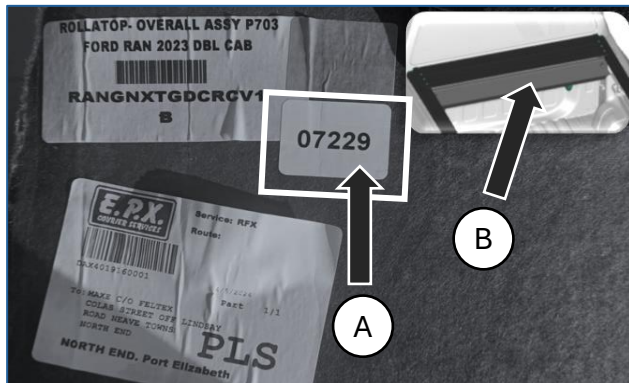
Figure.18 – Shown above is the tracking number, which is specific to each individual Rollatop. This number can also be found on the collection cylinder, either on the outside surface or on the inside under the fixed lid. Please supply Maxe with this number to order replacement keys, for warranty claims & spare parts.

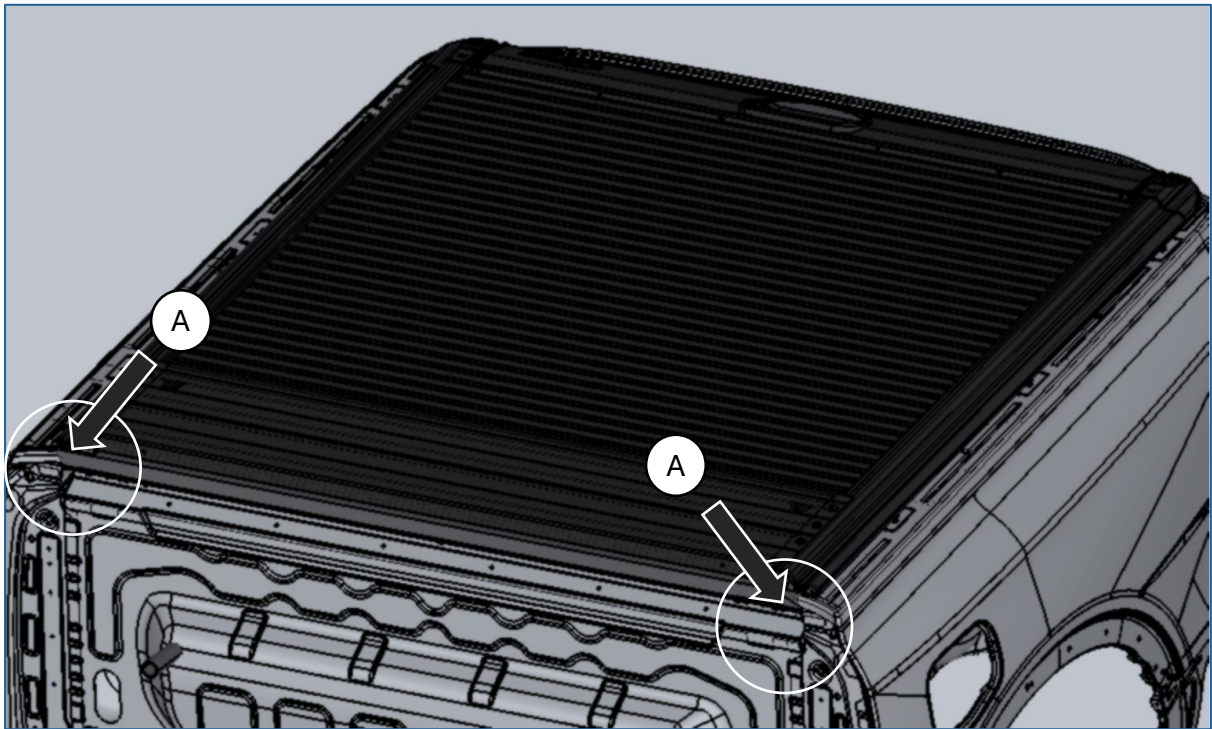
Figure.20 – Locate the front right-hand and left-hand sides.

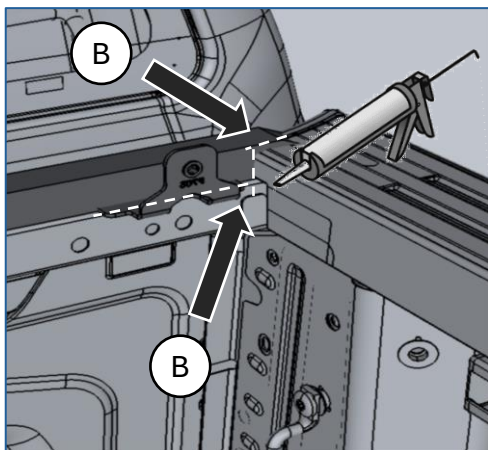
Figure.21 – Apply a silicone sealer to the area (RHS) shown above, once completed apply to the opposite side (LHS).

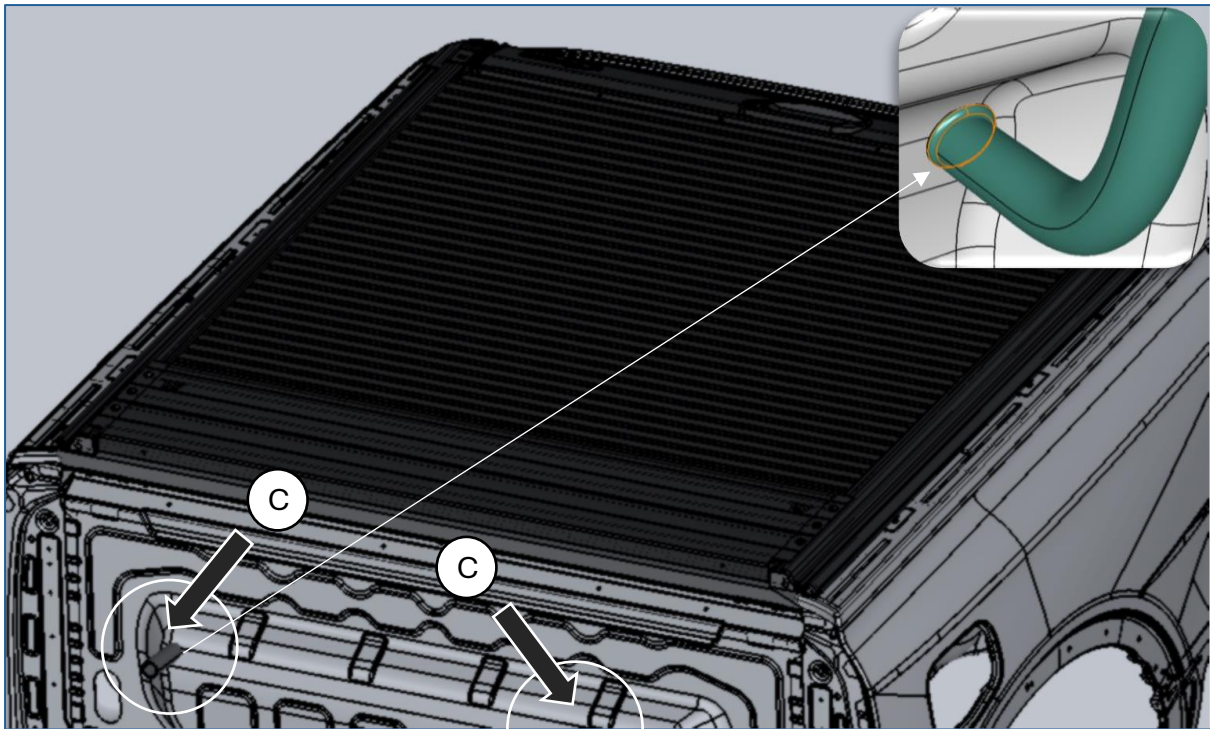
Figure.22 – Locate the front right-hand and left-hand PVC drain tubes. Ensure that these tubes are draining the water out of the bin.

Two Ø32mm holes need to be drilled through the bulkhead panel of the load bin for the two PVC tubes to drain water out of the bin.

Two black rubber grommets are supplied to fit into the holes then the PVC tubes are pushed through the grommets.

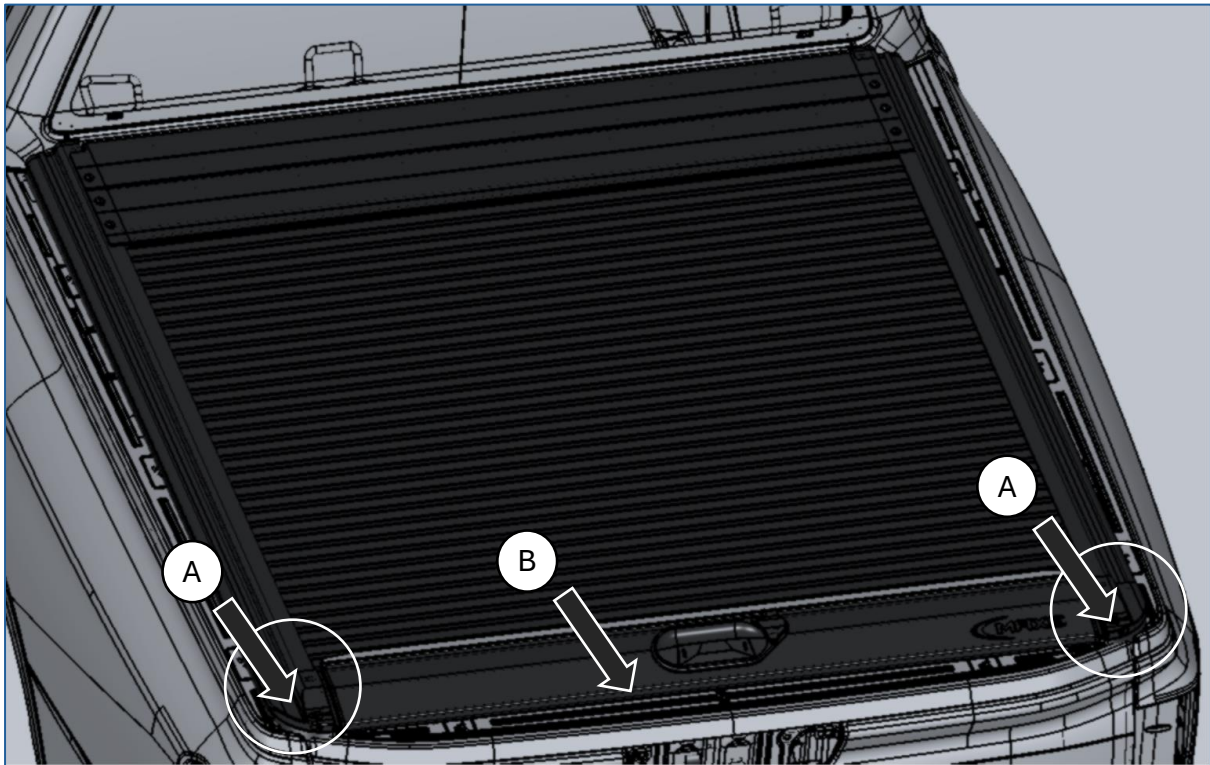
Figure.23 – Locate the plastic corner caps on the rear right-hand and left-hand sides. Then check the length of the rear profile seal.

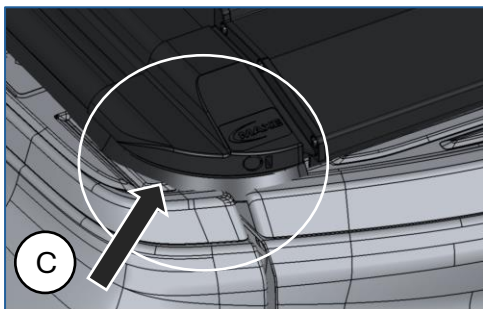
Figure.24 – Ensure that the rubber sill seal is placed correctly and not squashed under neath the side rail or trimmed too short allowing water to bypass.

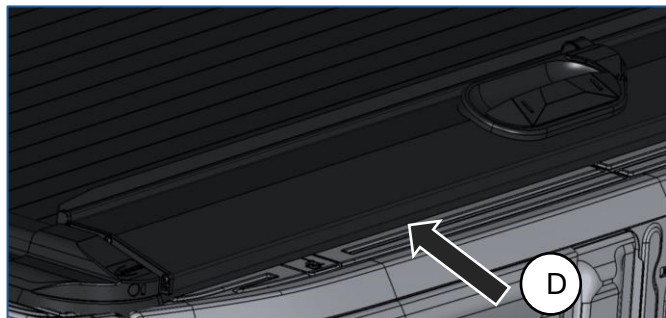
Figure.25 – Ensure that the rubber tailgate seal is forming a sealing along the full length of the tailgate. Excessive squish between the seal and the load bin may result in a poor seal join.

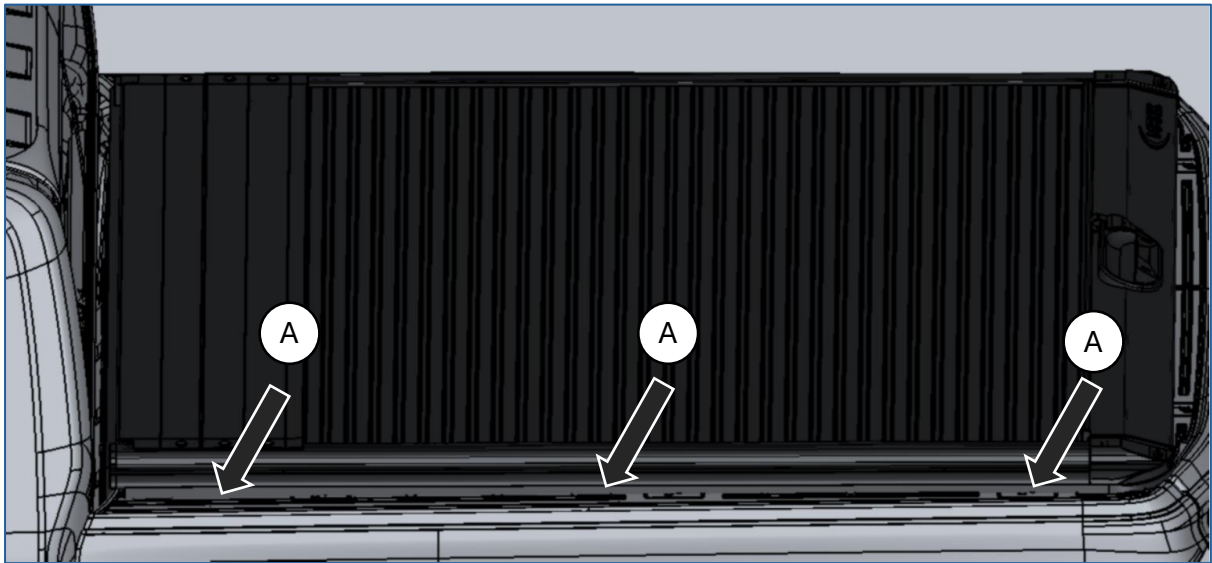
Figure.26 – Ensure that the rubber sill seals along the right-hand and left-hand side of the side rails are not squashed under the rails. Check for any visible damage or tears in the seal.

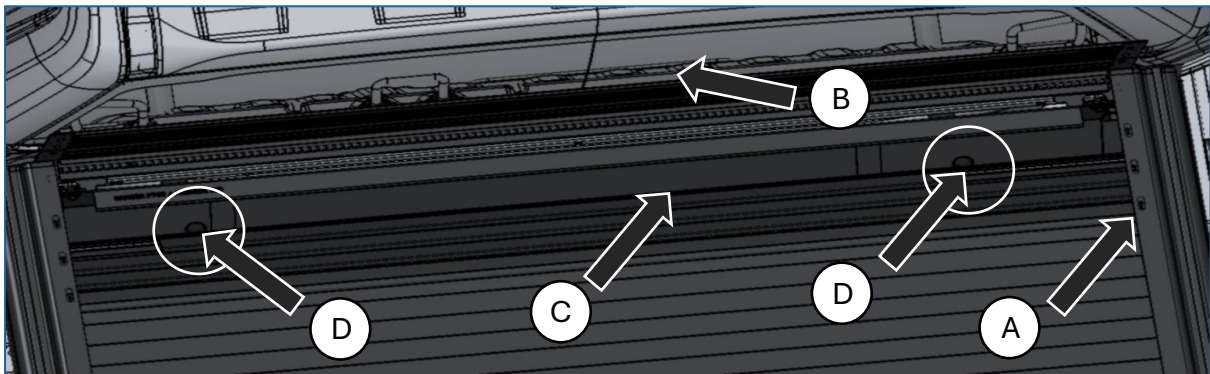
Figure.27 – Cleaning of the collection cylinder.

Once the 6x button head caps screws have been removed, rotate the lid 90 degrees to an open position to access the internals of the collection cylinder.

It is now possible to check for dirt build-up such as dust, leaves etc. remove all the unwanted dirt. Finally check to see if the two (2) drain tubes holes are clear for water to exit the cylinder.
